EXTERIOR ELEVATION STUDIES

WILLIAM T. COZBY PUBLIC LIBRARY

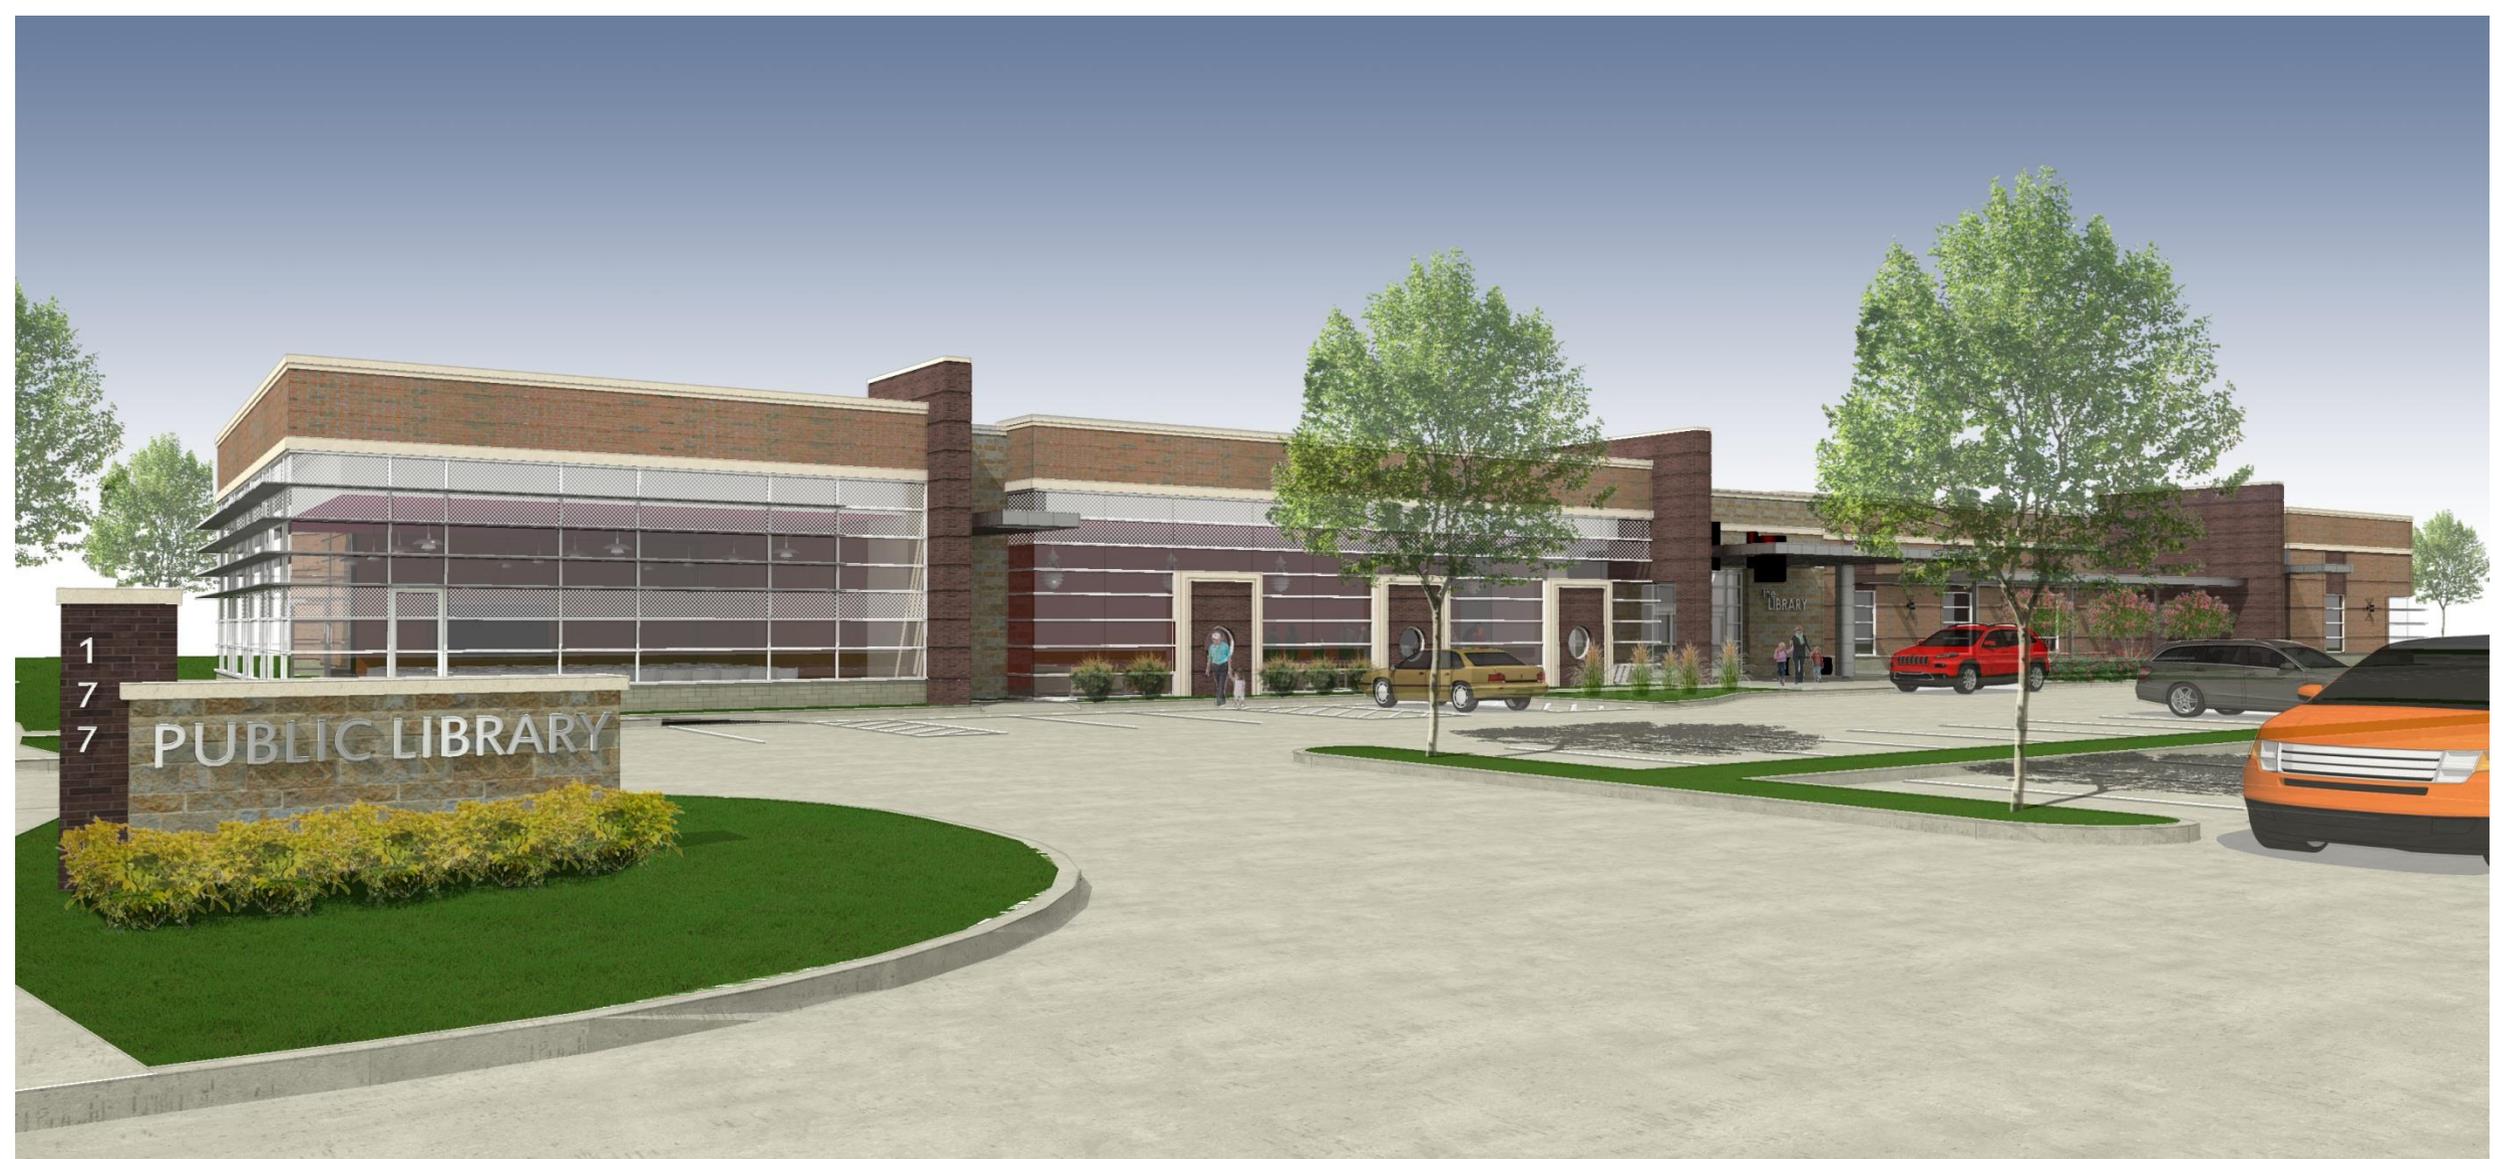
VIEW 1 of NE Corner MEETING ROOM and SOCIAL GATHERING EXPANSION

- **Meeting Room Expansion:** Stone base and masonry façade above glass. Glass to receive a ceramic "frit" with solar shading "fins" on all sides.
- **Social Gathering Expansion:** Clear glass with horizontal mullions and butt glazing with brick veneer panels and cast stone surrounds with punched round windows.
- Separation walls between Meeting Room and Social Gathering expansion and Main Entry consists of brick veneer.
- Rough stone façade and cast stone cornice at secondary exit of Social Gathering and at Main Entry. Each with a covered canopy.

The following elevation studies meet the code requirement of 80% masonry

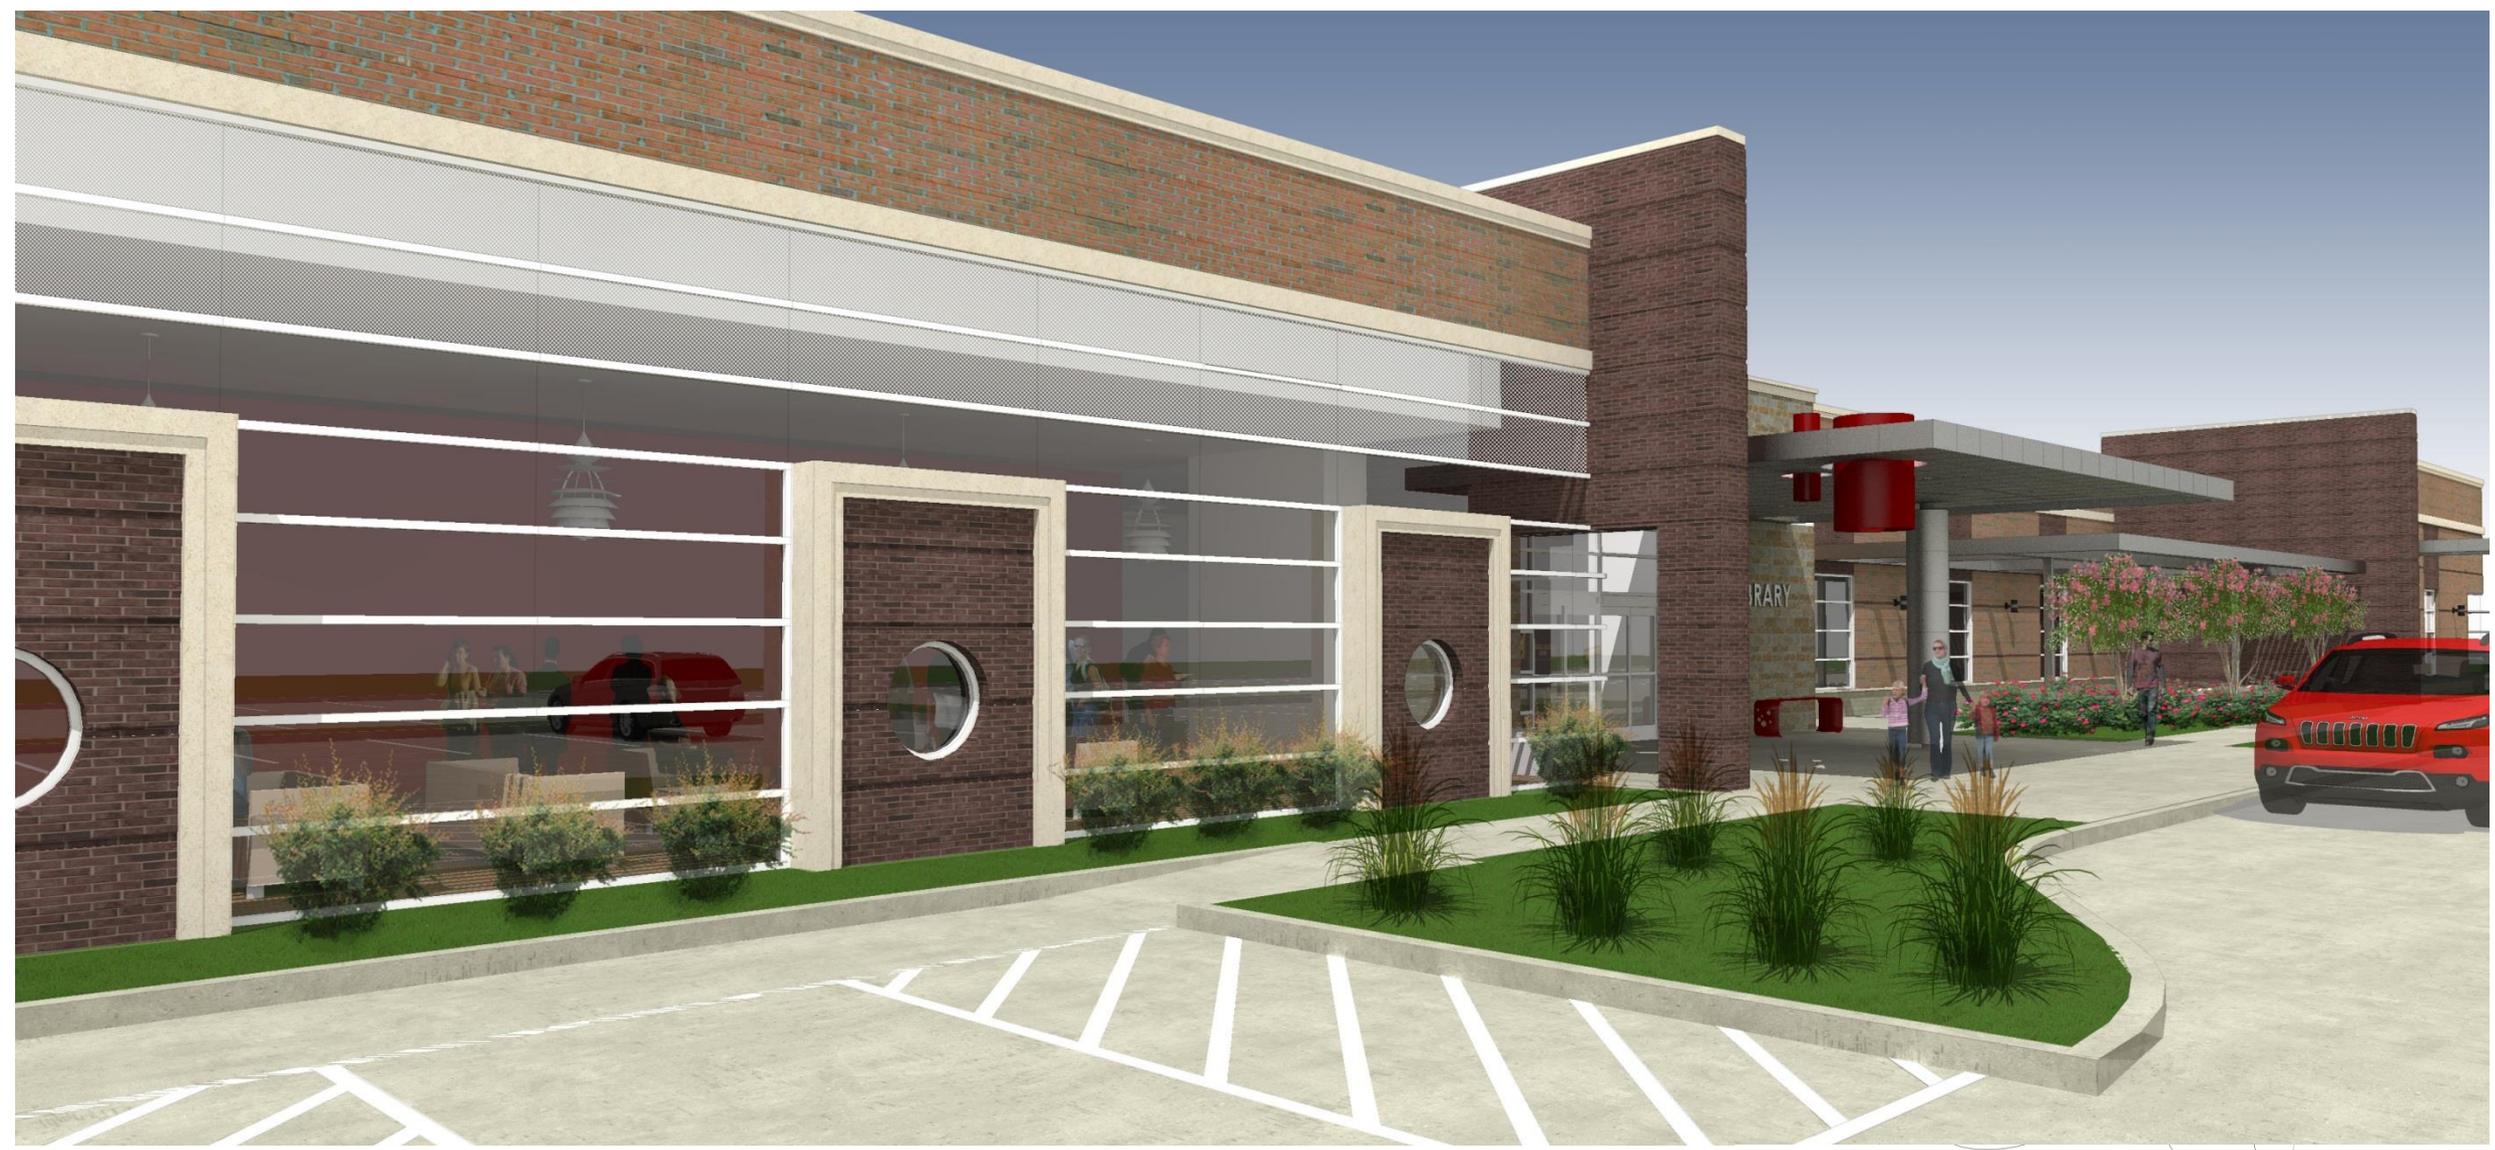
VIEW 2 of North Facade SOCIAL GATHERING EXPANSION, ENTRY and TRELLIS ARBOR

- **Social Gathering Expansion:** Masonry parapet above glazing; clear glass with horizontal mullions and butt glazing with brick veneer panels and cast stone surrounds with punched round windows.
- Separation wall between Social Gathering and Main Entry consists of brick veneer.
- Rough stone façade and cast stone cornice at Main Entry.
- Metal canopy and trellis arbor beyond with outdoor seating area

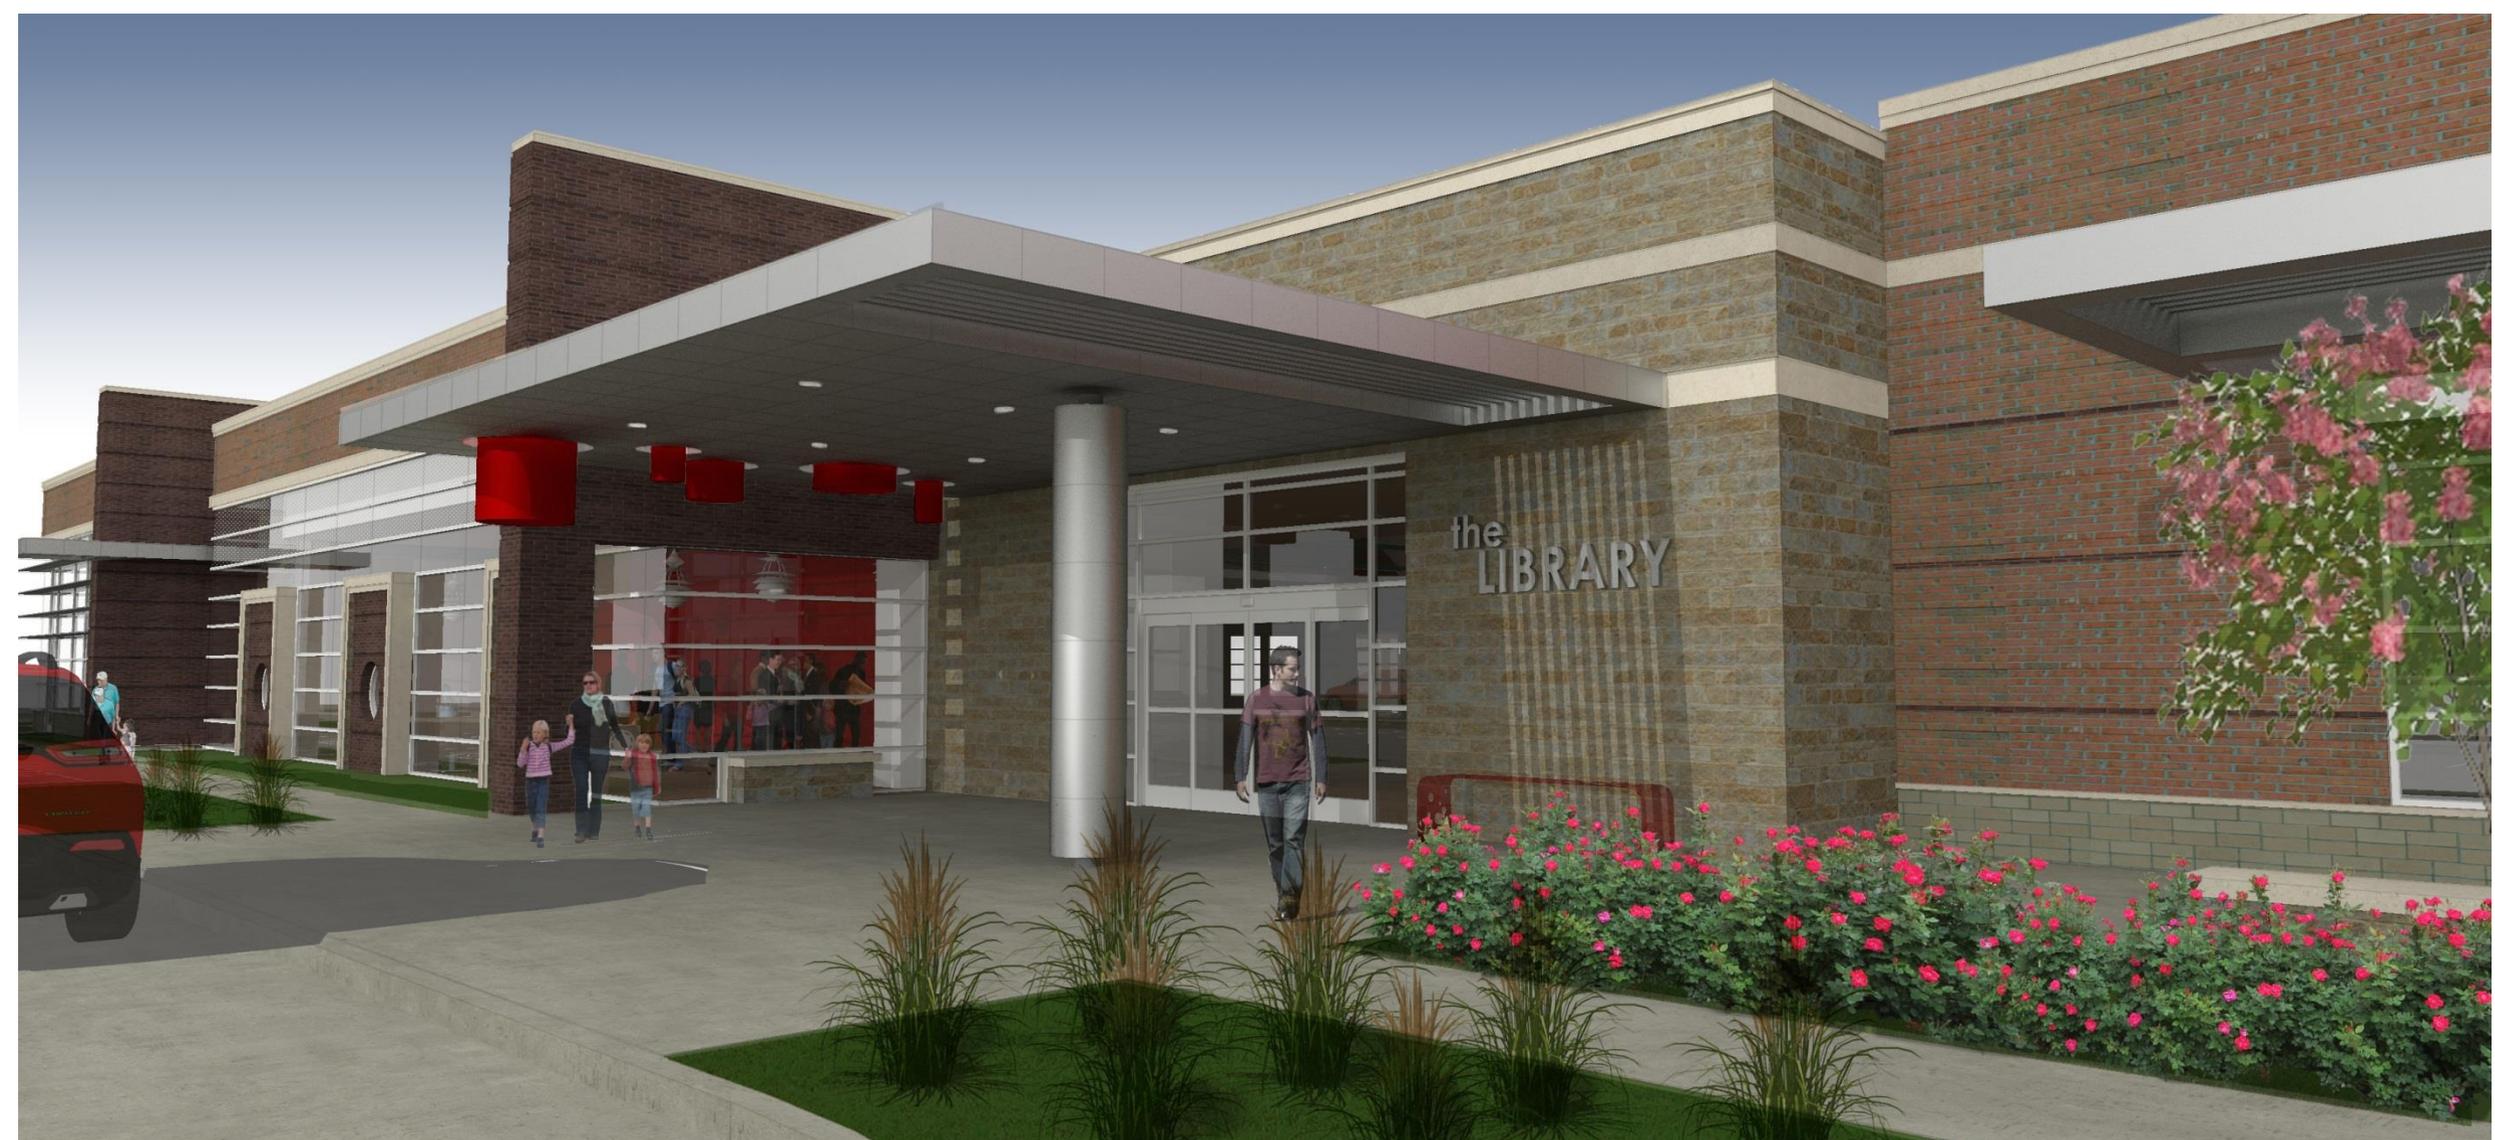
VIEW 3 of Front Entry MEETING ROOM and SOCIAL GATHERING EXPANSION BEYOND

- **Front Entry:** Metal canopy; illuminated at night with down and up lights. LED lights will illuminate the color of the main entry
- A partially open steel trellis combined with illuminated "red" cylinders to create an imaginative art interest within the canopy either thru open air or with colored fritted glass
- Separation wall at Main Entry consists of brick veneer.
- Rough stone façade and cast stone at Main Entry.
- Partially open steel trellis at outdoor seating area / arbor

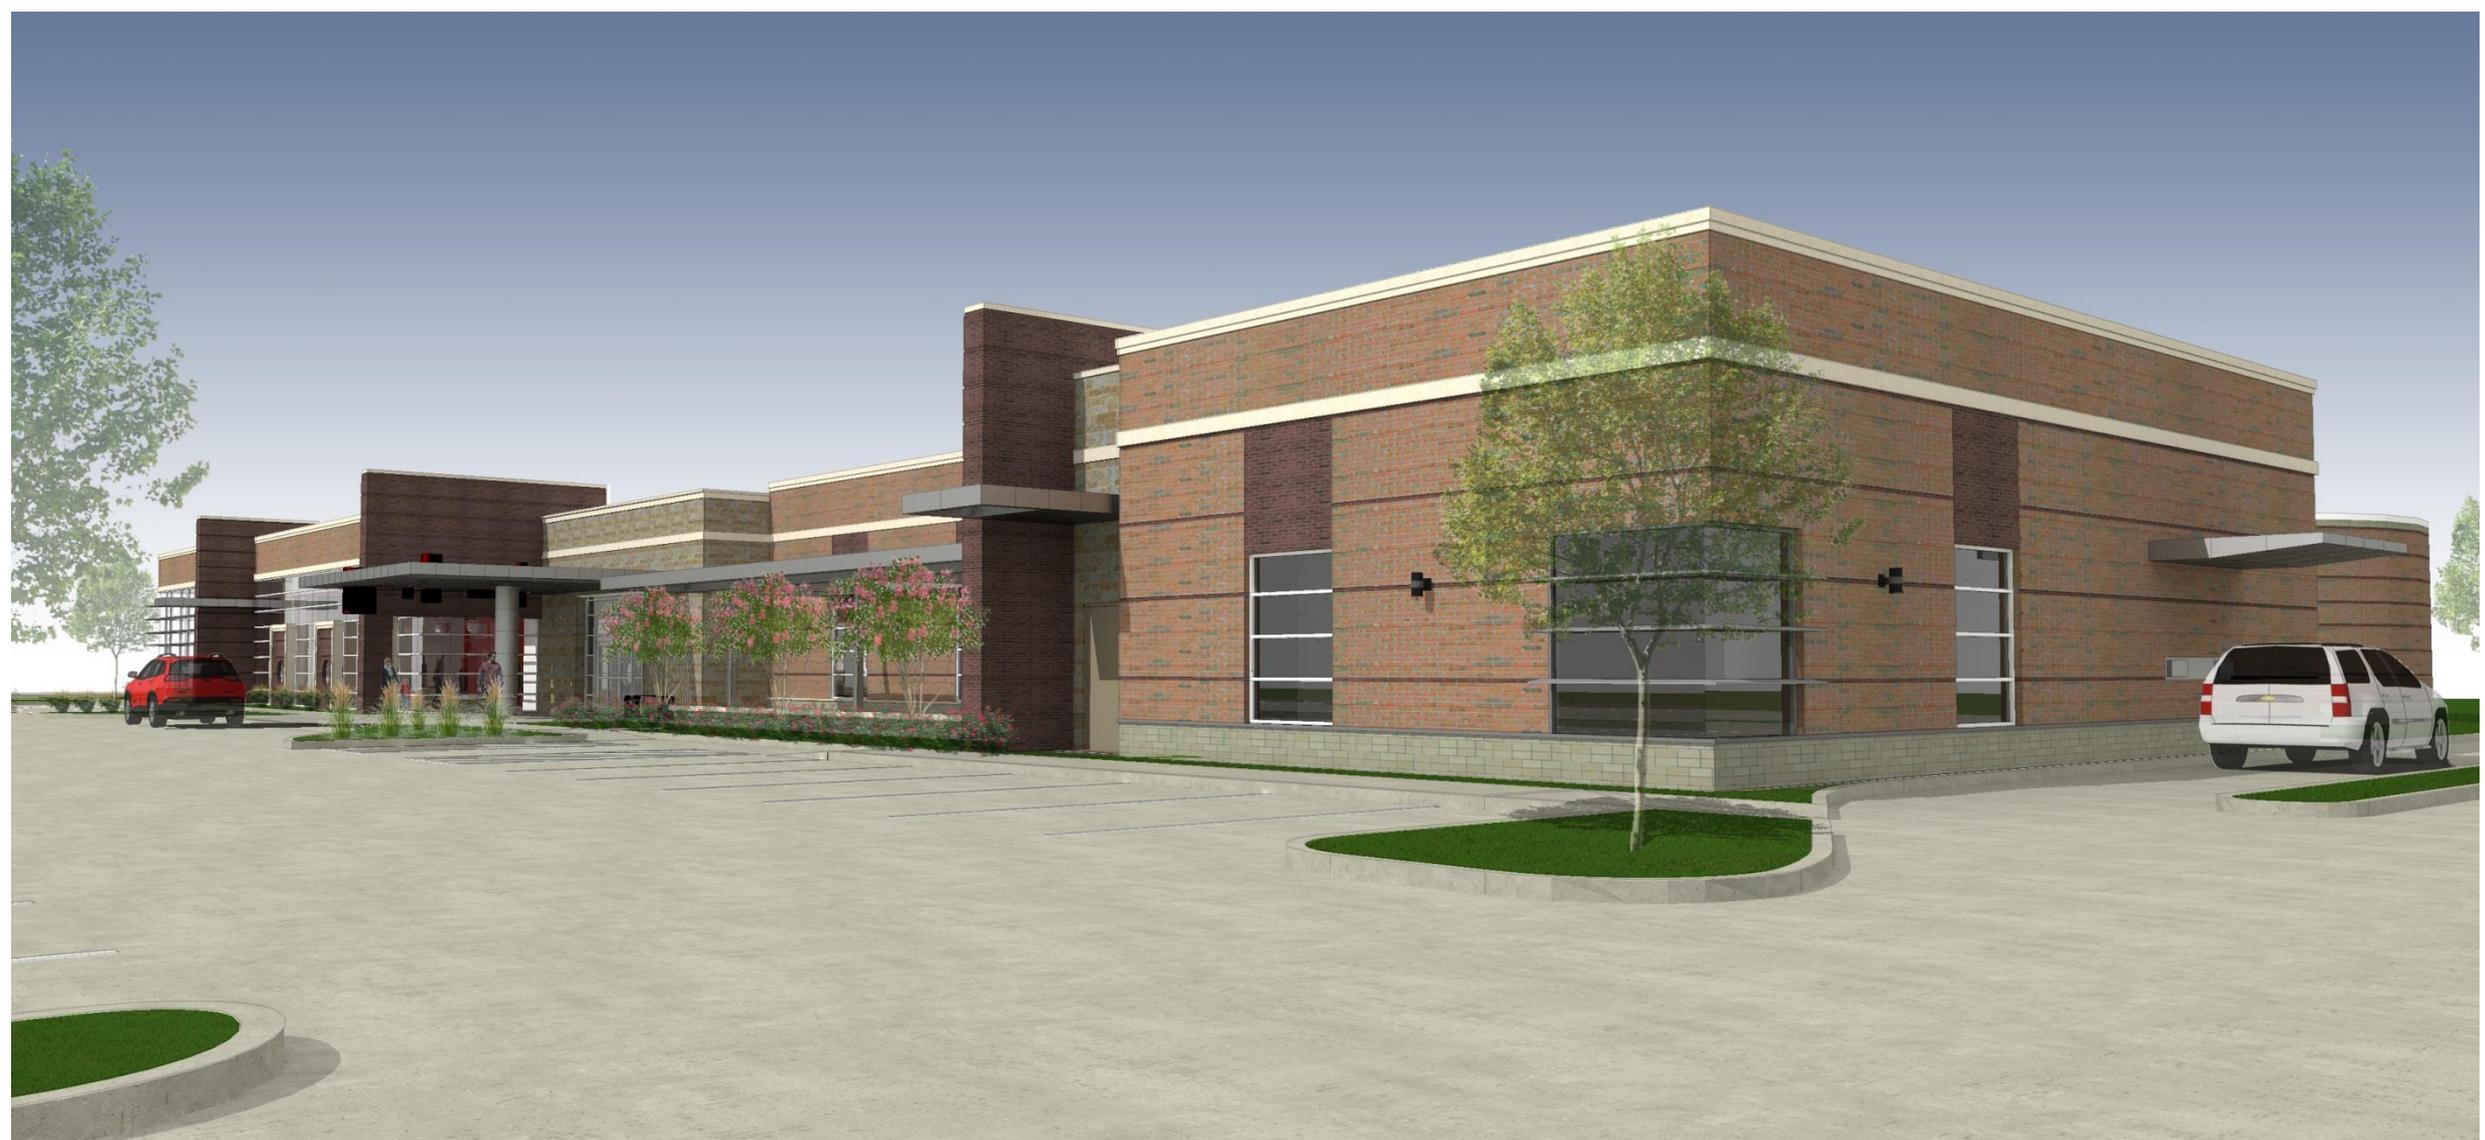
VIEW 4 of NW Corner STAFF EXPANSION AT DRIVE-THRU BOOK DROP

- **Staff Expansion:** Stone base, brick and horizontal accent banding to match existing. Ceramic "frit" and clear glass with shading fins at corner
- Drive-thru book drop with covered metal panel canopy
- Separation wall at Staff entry consists of brick veneer and covered canopy.
- Rough stone façade and cast stone cornice at wall of Staff Entry.
